TECHNICAL REPORT NO. 10456

M4 EXPANSIBLE VAN BODY

PHYSICAL TEST OF

AIRCRAFT TIE-DOWN AND LIFTING EYES

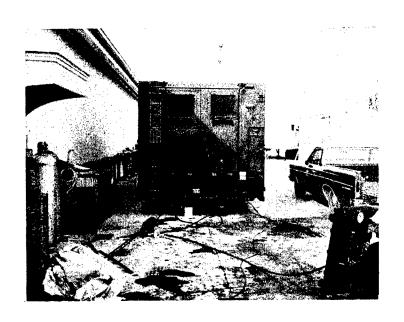
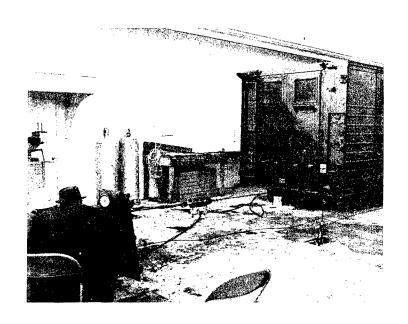
LOWER TIE DOWN TEST AT 20,000lbs.
